Manhole Inspection Summary

Manhole # S13EE_027MH

Location Address: **2824 BELMONT AVE** Cross Street: **POPLAR GROVE ST**

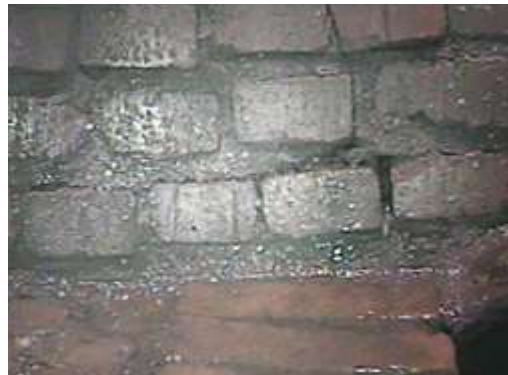
Defect 1

Comments **INFILTRATION THROUGH CRACKS IN BARREL ABOVE 4 O'CLOCK PIPE AND THROUGH CRACK AT 7 O'CLOCK (SEE PHOTO)**

Condition: ☐ Sound ☒ **Cracked** ☐ Root Intrusion ☐ Loose Brick ☐ Deteriorated

Infiltration: ☐ None ☐ Joint ☒ **Cracks** ☐ Mortar ☐ Roots ☐ Wall

INFILTRATION IN BARREL - CRACK @
7 O'CLOCK

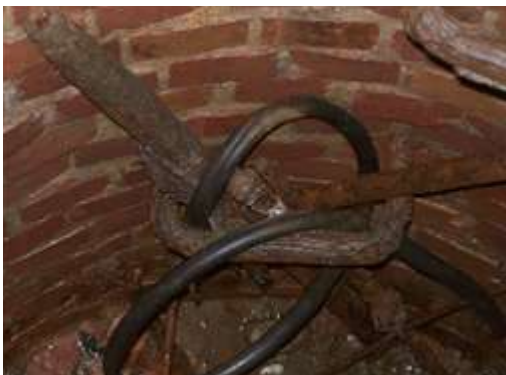
Defect 2

Surcharge ☒ **Evidence Of Surcharge** Depth: **3** (ft.) ☐ Active Surcharge Present

EVIDENCE OF SURCHARGE

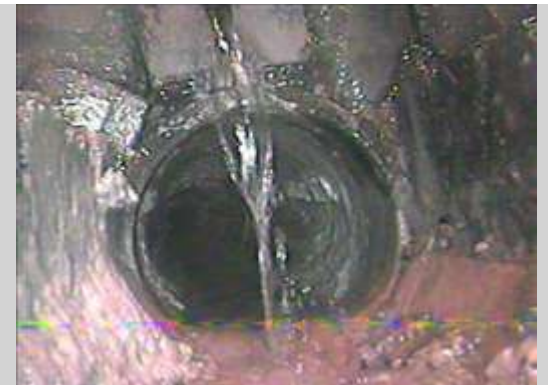
4 O'Clock Inflow

Infiltration: **Evidence** Pipe Seal Cond: **Sound**
